Reference: EPA Contract No. 68-W4-0006; Work Assignment No. R05052
Environmental Priorities Initiative (EPI) Assessments; Siemens-Furnas
Controls, Inc., Batavia, Illinois, EPA ID No. ILD005129069; PA/VSI Report
and NCAPS Scoring Report; Task 04 Deliverable

**PRELIMINARY ASSESSMENT/VISUAL SITE INSPECTION
FOR
SIEMENS-FURNAS CONTROLS, INC.
EPA ID No. ILD005129069
1000 McKEE STREET
BATAVIA, ILLINOIS**

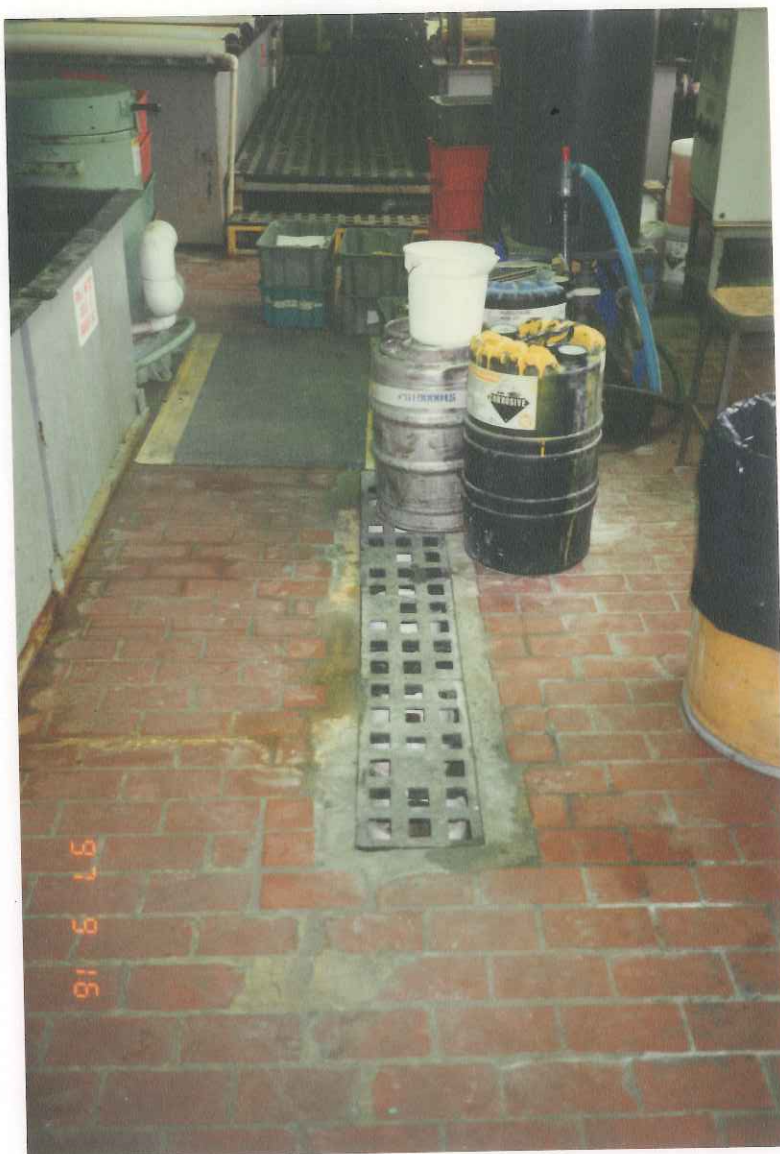
Report Photo No.: 23
Log Book Photo No.: 1-21
Date: 09/16/97

Description: View showing the Plating Room Collection Trough (SWMU 14) located in the plating line area. Rinse water from plating operations drains into this unit and flows northwards into the facility's wastewater pretreatment system.

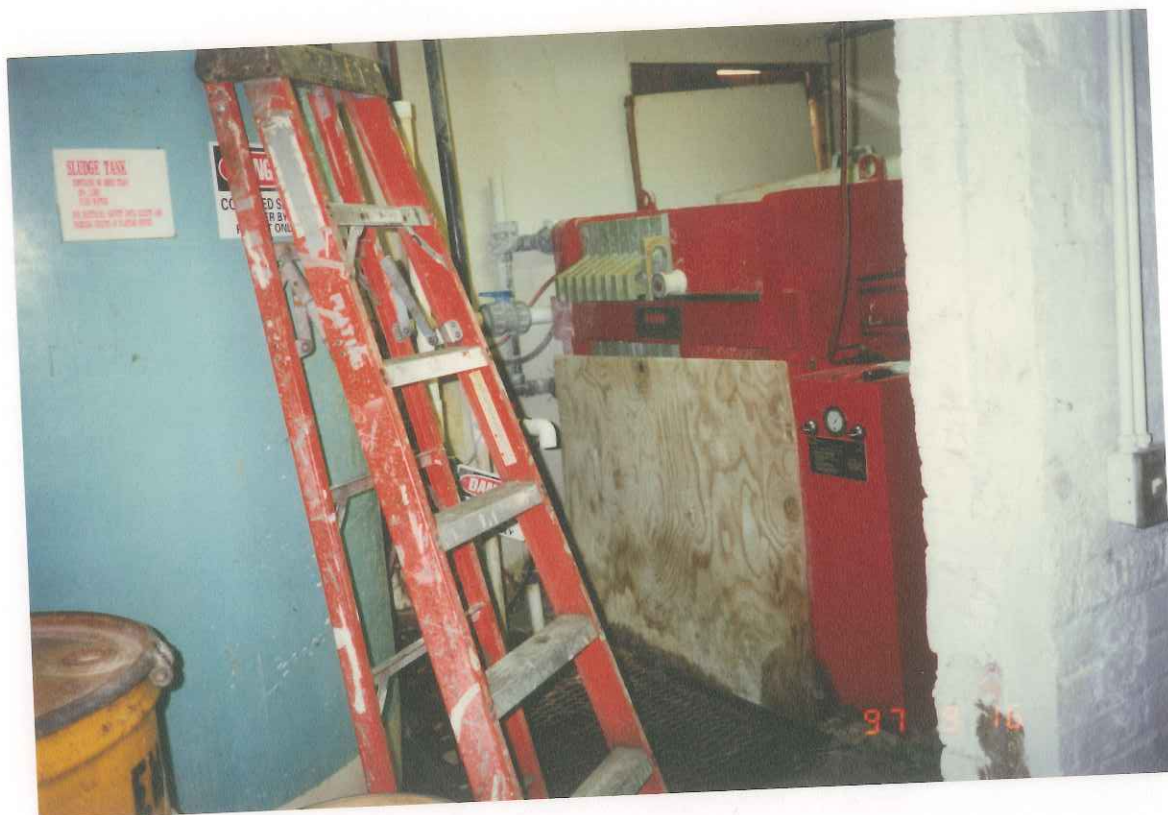
Report Photo No.: 24
Log Book Photo No.: 1-22
Date: 09/16/97

Description: View showing parts of the Plating Line Pre-Treatment System (SWMU 15) including a Sludge Tank and part of the metallic grate covering Pretreatment Line Collection Sump (SWMU 15b).

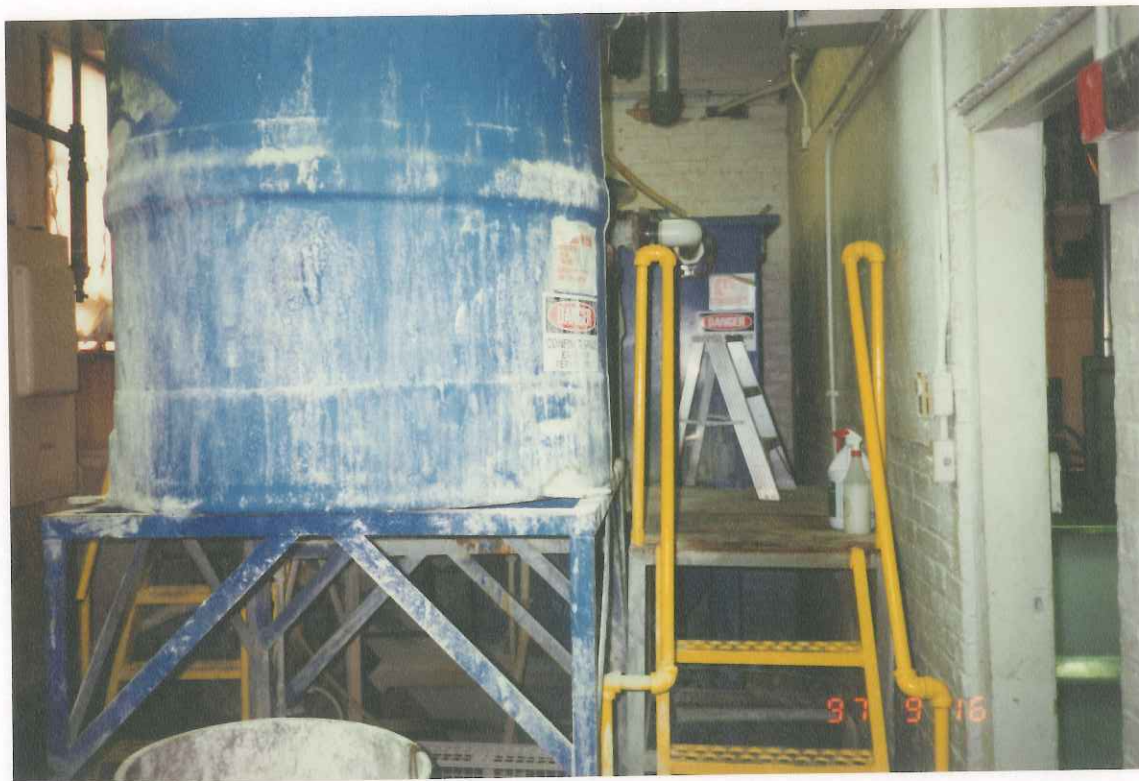
Report Photo No.: 25

Description: View showing one of the tanks of the Plating Line Pre-Treatment System (SWMU 15).

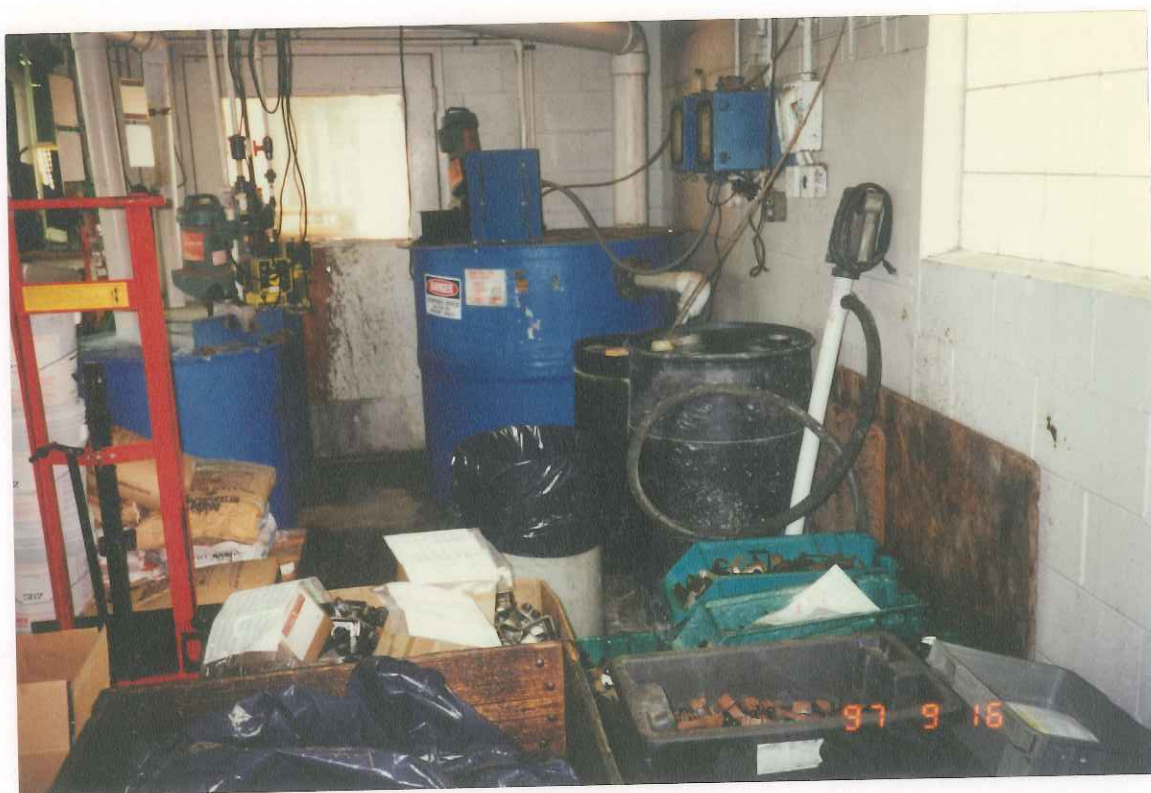
Report Photo No.: 26

Description: View showing the Chrome Reduction System (SWMU 15a) located in the Plating Room.

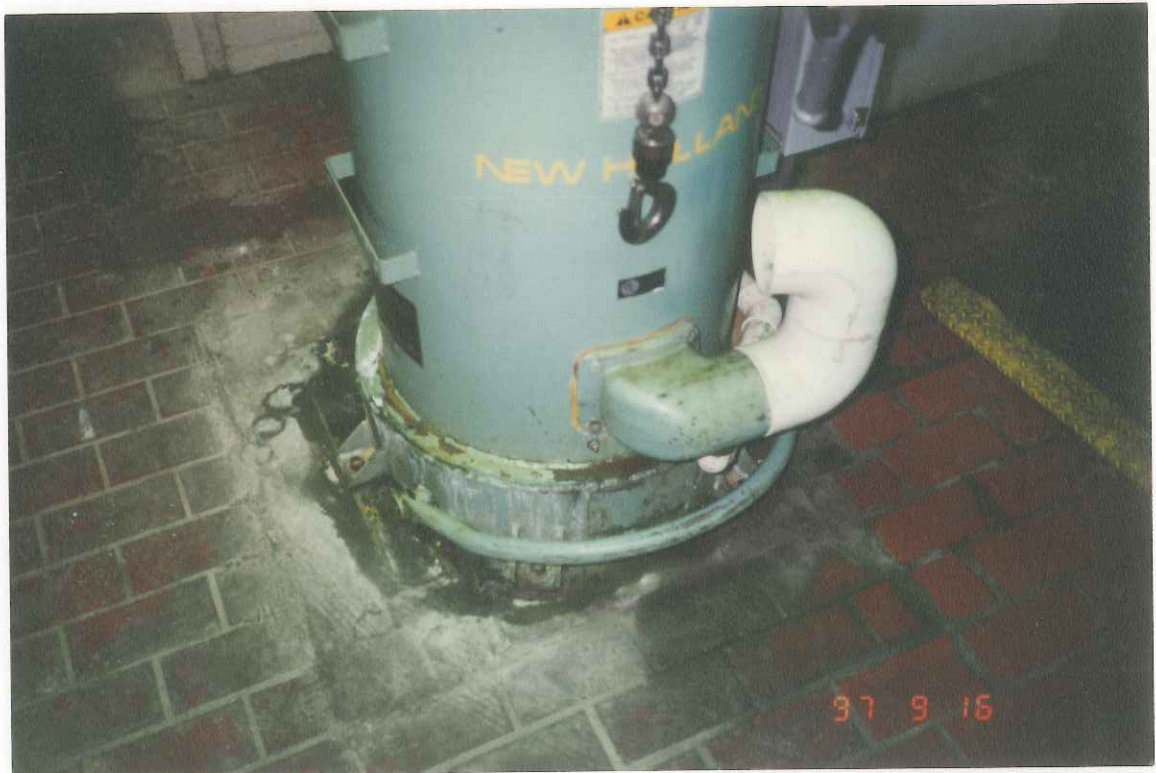
Report Photo No.: 27

Description: View showing the location of the Former Vapor Degreaser Collection Sump (SWMU 16) located in the Plating Room. At the time of the VSI, a spin dryer was sitting directly on top of the sump.
